# Manhole Inspection Summary

Manhole # S23E1\_008MH

**Location** Address: **2400 Harman Av**

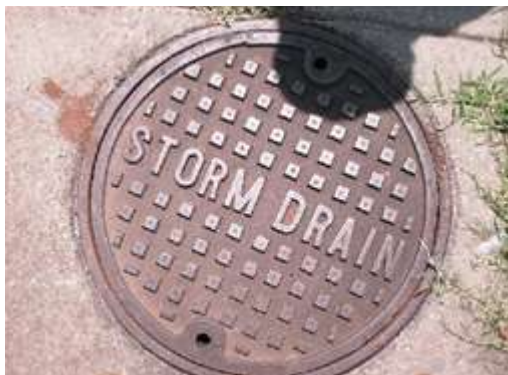
MH Cover

wrong lid

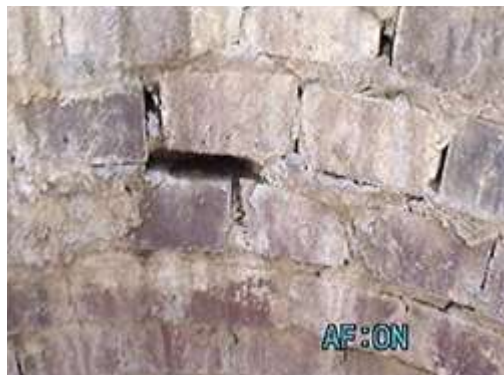
Defect 3

Condition: ☐ Sound ☒ **Cracked** ☐ Root Intrusion ☐ Loose Brick ☒ **Deteriorated**

Condition: ☐ Sound ☐ Cracked ☐ Root Intrusion ☐ Loose Brick ☒ **Deteriorated**

chimney cracked & deteriorated, corbel deteriorated

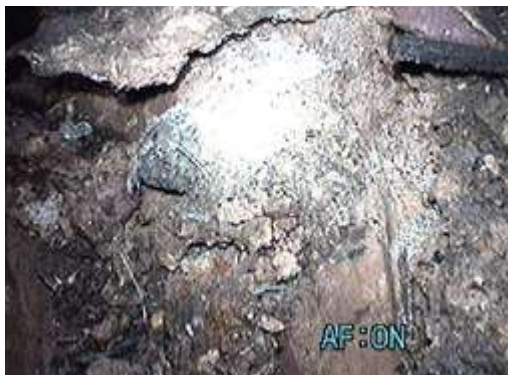
Defect 1

debris in channel

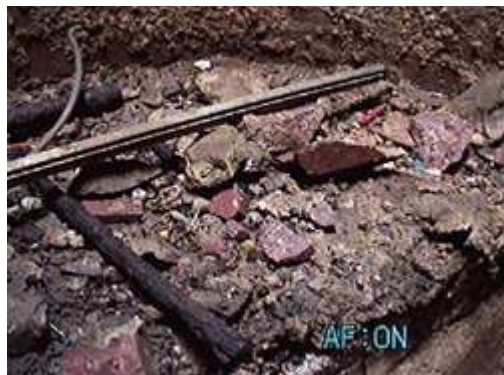
Defect 2

debris on bench

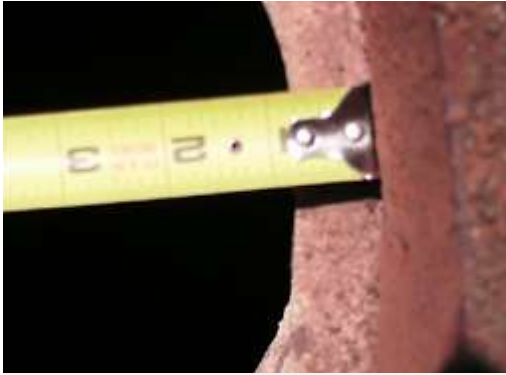
Defect 4

frame offset 1 inch

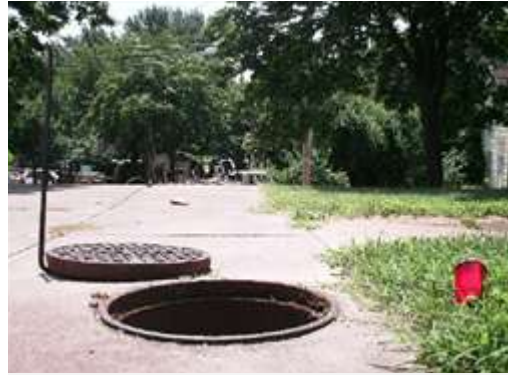
Defect 5

cover above pavement

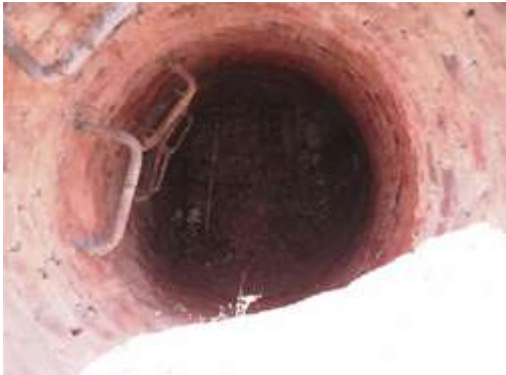
Defect 6

corroded steps

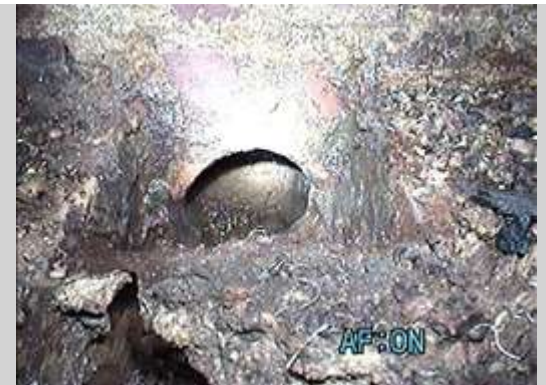
5 O'Clock Inflow

Pipe Height: **6** (in.) Rod and Bar (Angled)  
Pipe Material: **Clay** ☐ Pipe Lined  
Invert Depth: **12.49** (ft.) Flow Characteristics: **None**  
Deposits: ☐ None ☐ Mud ☐ Sludge ☒ **Debris** ☐ Grease  
Silt Depth: **2** (in.) Deposits Extent: **Medium**  
Infiltration: **None** Pipe Seal Cond: **Sound**
